DEPARTMENT OF TRANSPORTATION**DIVISION OF ENGINEERING SERVICES**

Quality Assurance and Source Inspection

Contract #: 04-0120F4Cty: SF/ALA Rte: 80 PM: 13.2/13.9File #: 69.28**WELDING INSPECTION REPORT****Resident Engineer:**Siegenthaler, Peter**Address:** 333 Burma Road**City:** Oakland, CA 94607**Report No:** WIR-021978**Date Inspected:** 12-Mar-2011**Project Name:** SAS Superstructure**OSM Arrival Time:** 1900**Prime Contractor:** American Bridge/Fluor Enterprises, a JV**OSM Departure Time:** 700**Contractor:** Zhenhua Port Machinery Company, Ltd (ZPMC), Changxing Island **Location:** Shanghai, China**CWI Name:** See Below**CWI Present:** Yes No**Inspected CWI report:** Yes No N/A**Rod Oven in Use:** Yes No N/A**Electrode to specification:** Yes No N/A**Weld Procedures Followed:** Yes No N/A**Qualified Welders:** Yes No N/A**Verified Joint Fit-up:** Yes No N/A**Approved Drawings:** Yes No N/A**Approved WPS:** Yes No N/A**Delayed / Cancelled:** Yes No N/A**Bridge No:** 34-0006**Component:** OBG**Summary of Items Observed:**

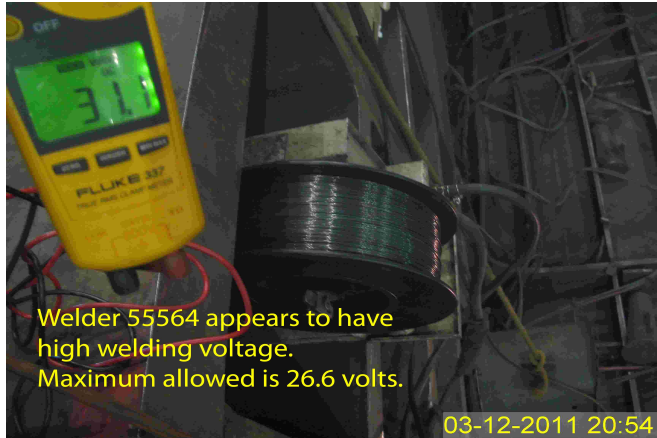
This QA Inspector observed ZPMC welder Mr. Zhu Jibo, stencil 055564 used flux cored welding procedure WPS-B-T-2232-ESAB to make OBG segment 13AE weld SEG3007AH-030. This QA Inspector measured a welding current of approximately 265 amps, and 30.0 volts. This QA Inspector observed the maximum welding voltage listed in the welding procedure specification is 26.6 volts and Mr. Zhu Jibo had a welding current that was approximately 3.4 volts above this maximum limit. This QA Inspector showed ABF CWI Mr. Bao Qian the welding meter and he had the welding machine adjusted to have a voltage of approximately 26.0 volts. Following adjustment of the welding machine, items observed on this date appeared to generally comply with applicable contract documents. See the photograph below for additional information.

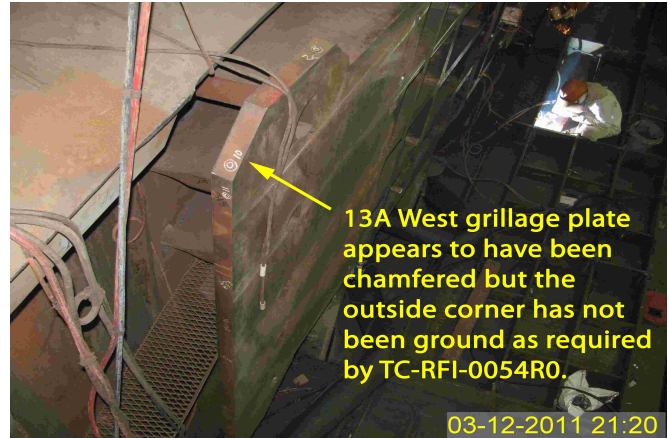
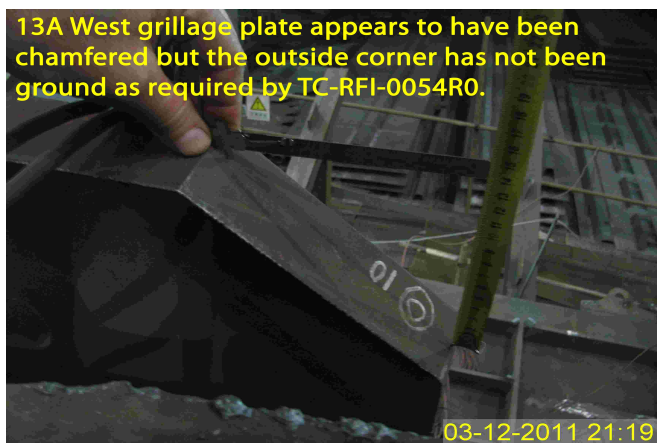
Segment 13AW

This QA Inspector performed random document review of "Team China request for information (TC-RFI)" document #TC-RFI-0054R0. This RFI addresses OBG segment 13AW west bound top east corner of the east saddle grillage connector plate. This QA Inspector performed random visual inspections of the plate listed in the RFI and observed the grillage plate appears to have been chamfered as stipulated in the RFI. ZPMC has not drilled the bolt holes or ground the outside corner of this grillage plate. This QA Inspector took random photographs of some of this plate and copies of the photographs and other related information have been placed in

“TC-RFI Documentation” folder located on Team China common Z drive pending engineering review. See the photographs below for additional information.
